Review Of The History And Restoration Of Mor Efrem Monastery In Mardin - Türkiye

Fatma SEDES

Ass.Prof.Dr., Istanbul Aydin University

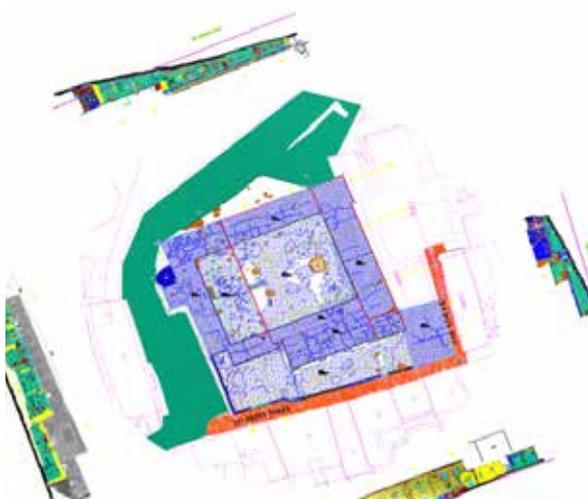
Fig.1 Situation plan (Bozyel,2020)

Located in Mardin Province, Artuklu district, at the entrance of the Urban Conservation Area, registered at the address Çabuk Mahallesi 241 Erdes street, No:56, located in the Land Registry records 31-32-N-B Map, block 29, parcel no. 73 (Fig.1) The main subject of this study is to compensate the damage caused by the phases and uses of the building over time, to restore the value it creates in terms of its location and cultural property, by repairing and using the building, and by giving some parts of it new functions in line with today's needs, to open up

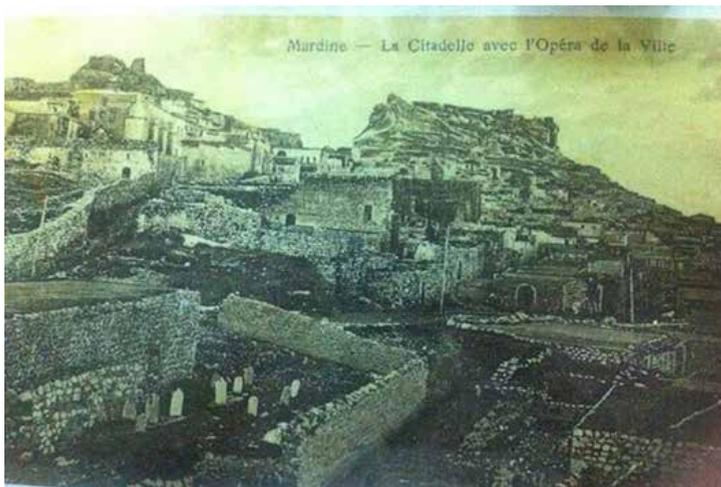
Fig. 8, Photograph of the Abbey in the Early 1900's (Albert Gabriel)

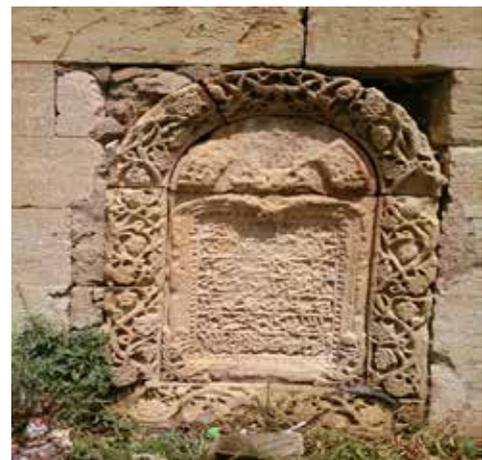
Fig.9, Lower Level inscription on the Southwest wall of the Church (Bozyel,2020)

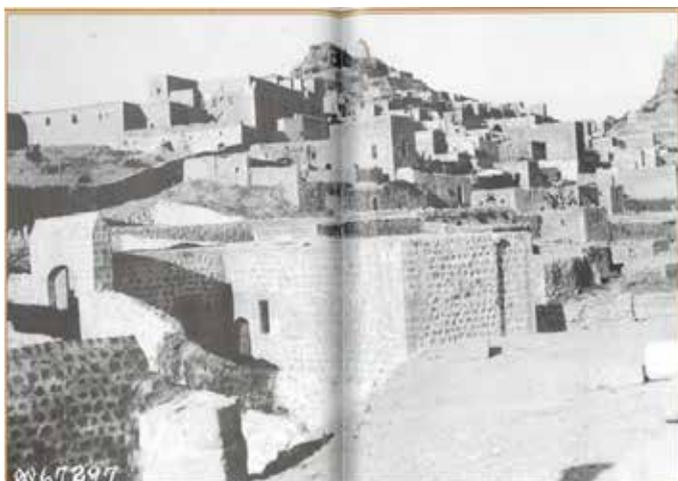
Fig.10, Old Photograph of the Church (Albert Gabriel,1933)

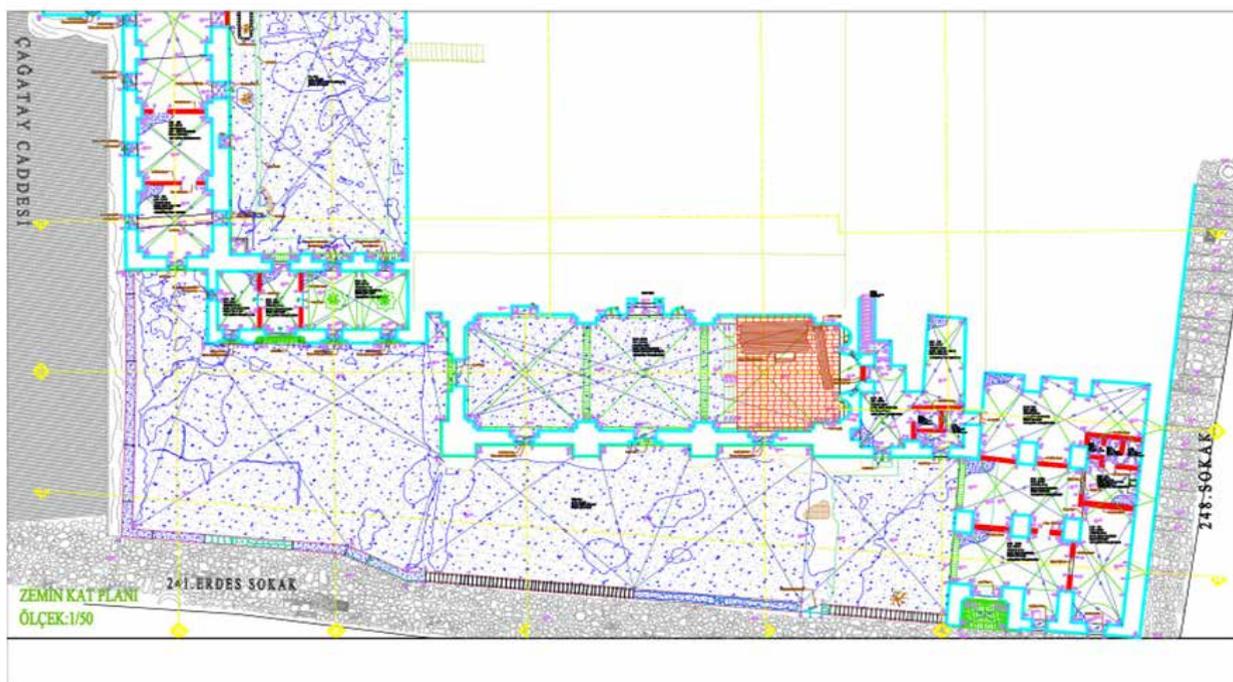
Fig.11, Ground Floor (Bozyel, 2020)

Today, engineers who have experience on masonry and wooden historical structures examine the monument to be restored, determine the damages and develop suggestions for the reinforcement of the elements (foundation, wall, column, foot) that they find insufficient against earthquakes or vertical loads (Figs.11,12). Since interventions that distort or change the general appearance of the monument are not preferred, consolidation proposals that will create such inconveniences are avoided as much as possible. Unseen consolidation techniques that can be hidden inside the monument are preferred. Impulses from curvilinear elements such as earthquakes, arches, vaults, domes, etc., on the ground, may cause them to separate from the vertical and crack. The damaged masonry structures of the old architects and craftsmen were strengthened by placing massive or fl-

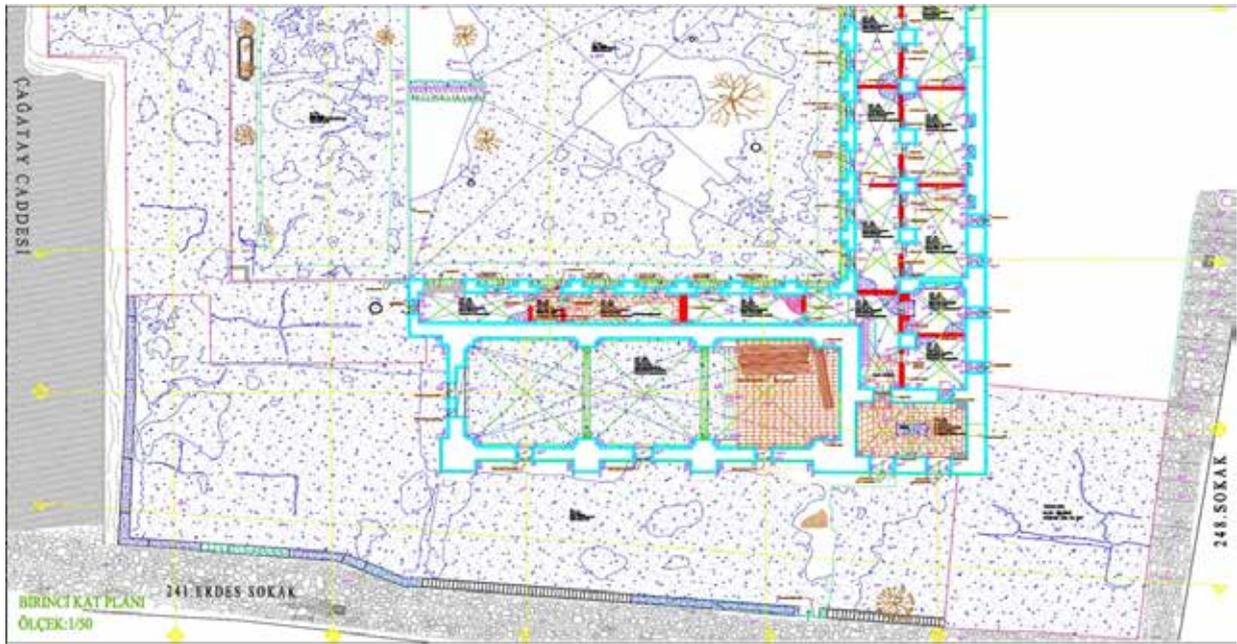
Fig.12, First Floor (Bozvel,2020)
