## Rebuild, Renovate and Reusing the Old Borsa Han (Çifte Han) Istanbul Aydın University

Tarek Naser, Istanbul Aydın University, Turkey  
tareknaser@stu.aydin.edu.tr

**Key words:** rebuild, renovate, restoration techniques, Khan Old Borsa (ÇIFTEHAN), Khan Al Wakala, historic buildings at Diyarbakir.

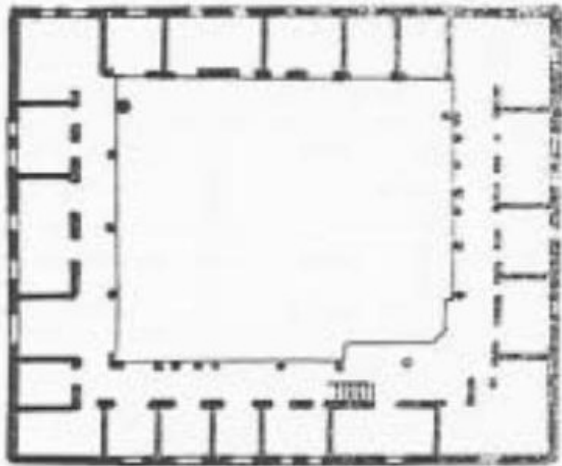
Figure 4. Plan of khan ÇIFTEHAN(1)

The ÇIFTEHAN khan consists of two buildings with two floors. For this reason it is called "Çifte Han" double inn. It was considered as a double inn during the first construction, and the second one was destroyed during the road opening in the 1940s. If the entire rest of the building on the old status it will form a different application example in the form of a two-storey house adjacent to the Diyarbakır khans [Figure 4][3].

Çiftehan khan is made of cutting black basalt stone. There is a courtyard in the middle and arched porticoes on three sides of the courtyard. The entrance door a little further ahead than, a ladder on the left side provides connection to the upper floor [Figure 5].

The entrance floor of the khan is used as a storage and the upper floor is not used. In Bodrum there is an barn department. This khan has remained leaner than the Deliler khan and Hasan Pasha khan.

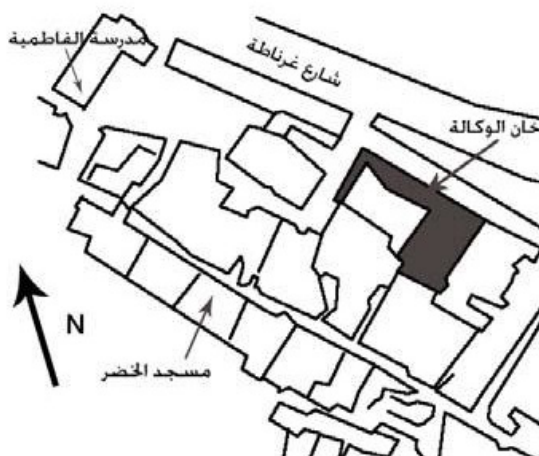
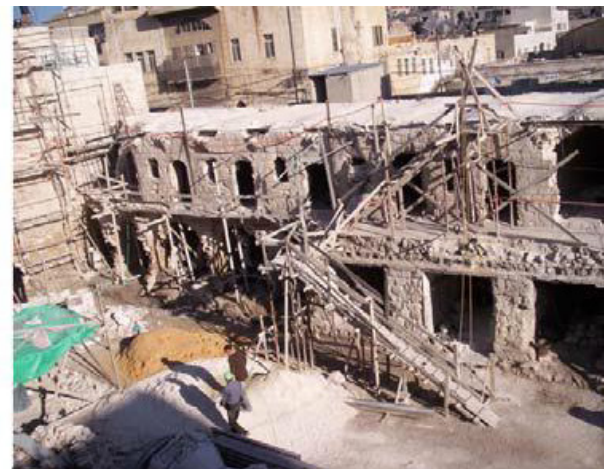
Figure 6 . Khan al-Wakala site on the outskirts of the old town of Nablus (2).

irregular polygon contains corridors hung serving the upper floors, and a large number of rooms spread over two floors in the north, east, and south, and three floors on the west side [Figure 6].

The average width of a single chamber 2.5 m and a depth of about 3 meters were used to sleep on the upper floors either lower floors was used stables and places to store the goods. Representing eastern and northern closets inside the entrance to the stables, while the northern rooms overlooking represented on the main street shops belonging to Khan al-Wakala [6].

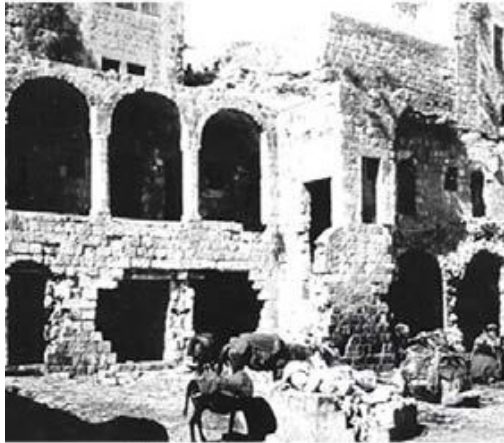
**Figure7.**Khan al-Wakala after 1927 the Israeli invasion in 2002 (3).

The building has lost many of its parts in the 1927 earthquake, it has faltered western segment and the entire west side of the southern part of the courtyard, and he was about 15 chamber Figure 8 Then in the invasion of Israeli forces to the city of Nablus in 2002 it was demolished the gate completely. Subsequently, the

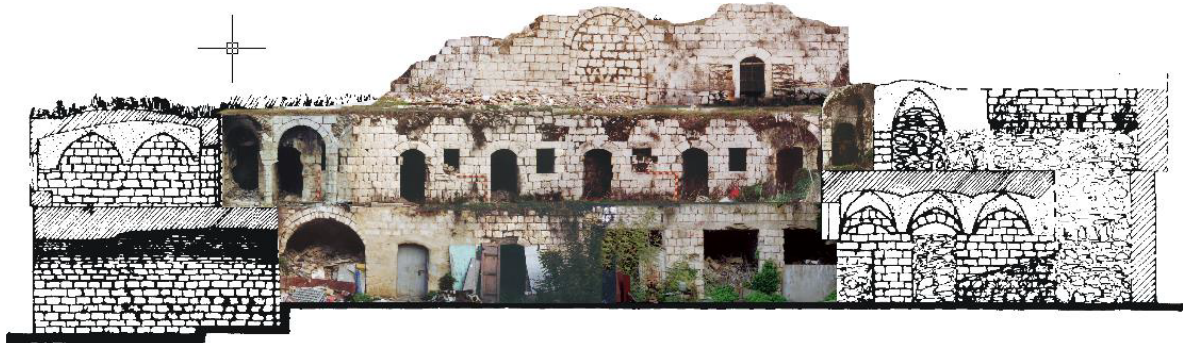
Figure 11. Interior eastern elevation\_existing situation

building damage and neglect factors during the previous years, In addition, the building was originally built low-quality materials and on several stages at different time intervals [8]. Figure 11-12-13 shows the status of Khan Al\_wakala before restoration.

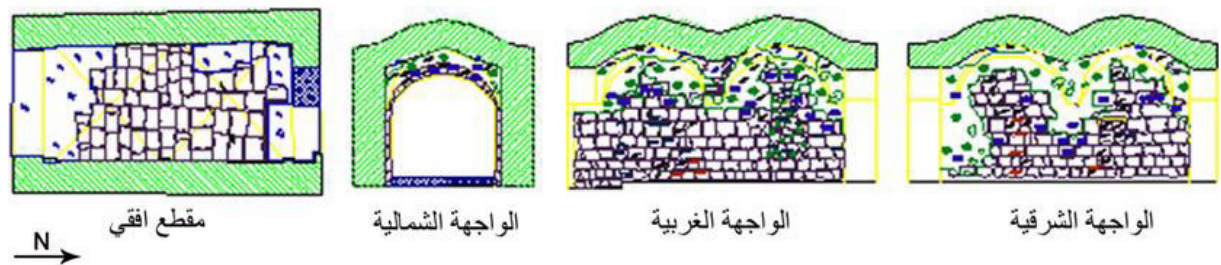
Photography, mapping and take down twice built upon points. Figure 14-15.

Figure 15. Document the damage inside a khan rooms before restoration

A form to document the damage inside a khan parts and elevations before restoration (2).

Been through countless documented many problems in the building, the most important of the presence of dust and debris that was covering most areas of the building and hide a lot of attractions, as well as the implications of the building and parts of ramshackle stone because of corroded and lost. Amaallenbataat, herbs and algae, they were caked in most parts of the building, causing cracks and crevices longitudinal and lateral [8].

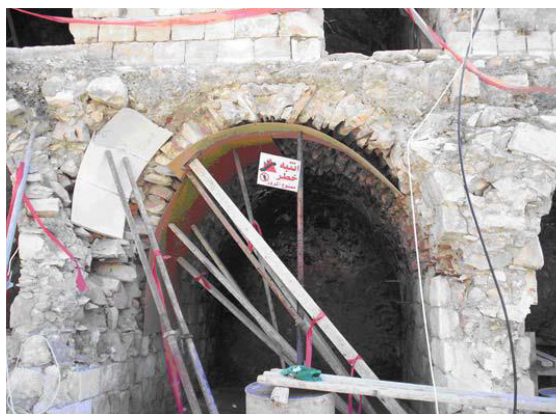
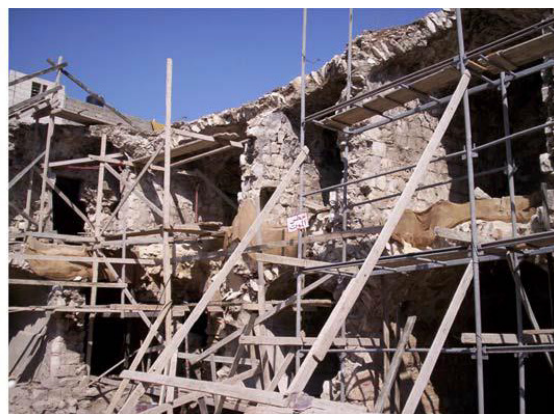
**Figure 16.** To the right business consolidation by wooden struts of the northern facade of Khan, to the left to strengthen the roof of one of the rooms in the building from the inside by pillars (3).

Strengthening the interfaces, stone processing, processing plastering, the removal of harmful algae and plants, and processing of cracks and crevices.
